CAMBRIDGE PUBLIC SCHOOLS

BUILDING INTERIOR MOISTURE & HUMIDITY ISSUE ANALYSIS

December 21, 2018

Cambridge Public Schools – Building Interior Moisture & Humidity Issue Analysis
Cambridge, MA
J#671 001 00.00

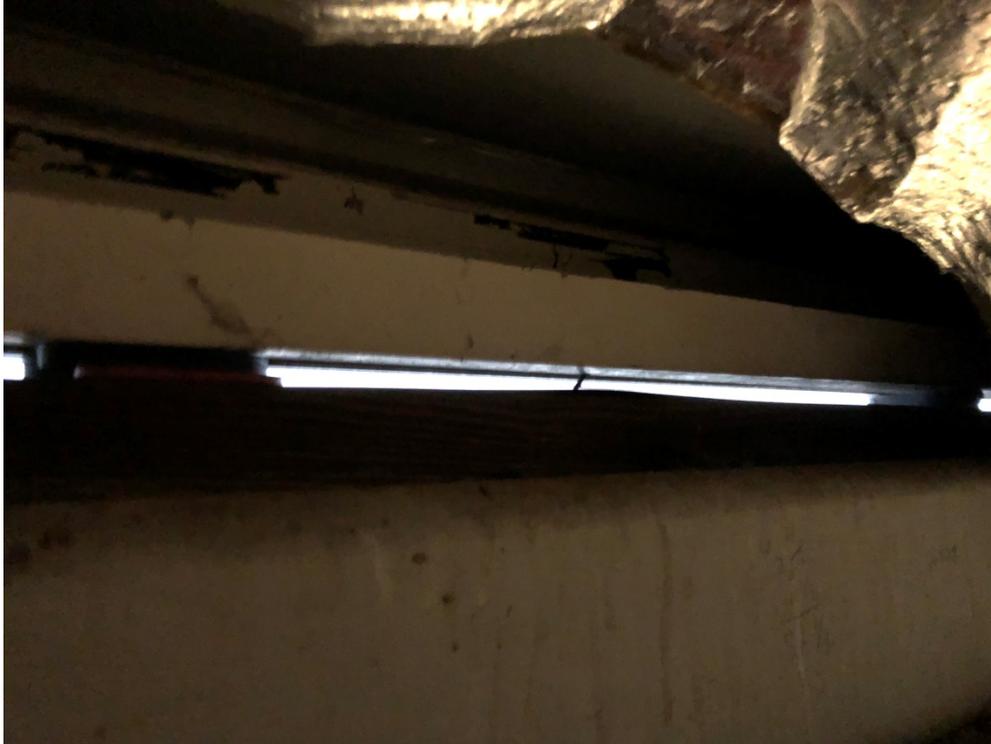
- Daylight is visible through sections of the building envelope from within the indoor ceiling cavity. This condition allows for un-resisted infiltration from the outdoors and must be improved upon in order to alleviate the building interior environment issues.

Visible Gap in the Building Envelope from within the Ceiling Space

- Verify that all heating-only control valves associated with the dual-temperature HVAC piping system are closed during the cooling season.
- The building envelop must be repaired in order for any HVAC system revisions or improvements to be effective. Currently, the HVAC system is attempting to cool the outdoors, in essence.

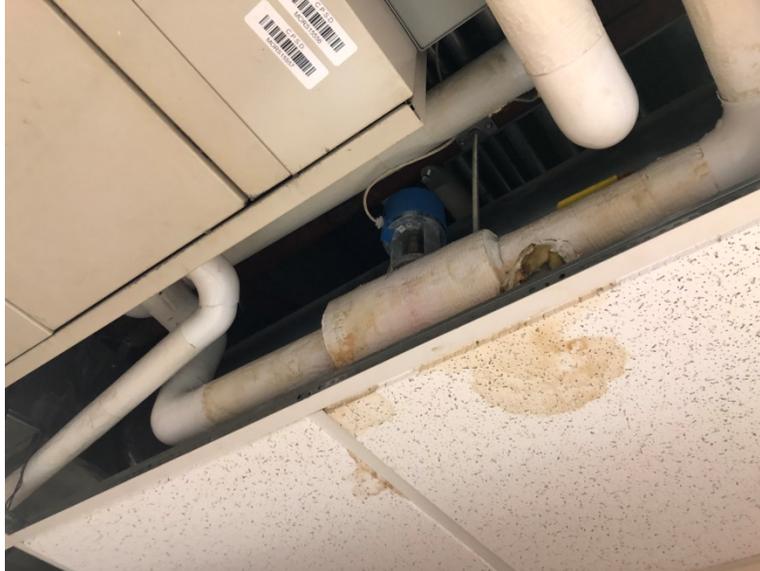
- In addition to condensation often present on the HVAC piping systems, the ductwork and air terminals are showing signs of damage from excessive condensation due to failed or missing insulation and vapor barriers.

Ceiling Damage Caused by Failed Insulation & High Ceiling Cavity Humidity

- Repair all duct insulation & provide insulation where currently missing. Insulation with vapor barrier should be continuous from the discharge of the associated air-handling unit to each diffuser including the neck and duct connection.

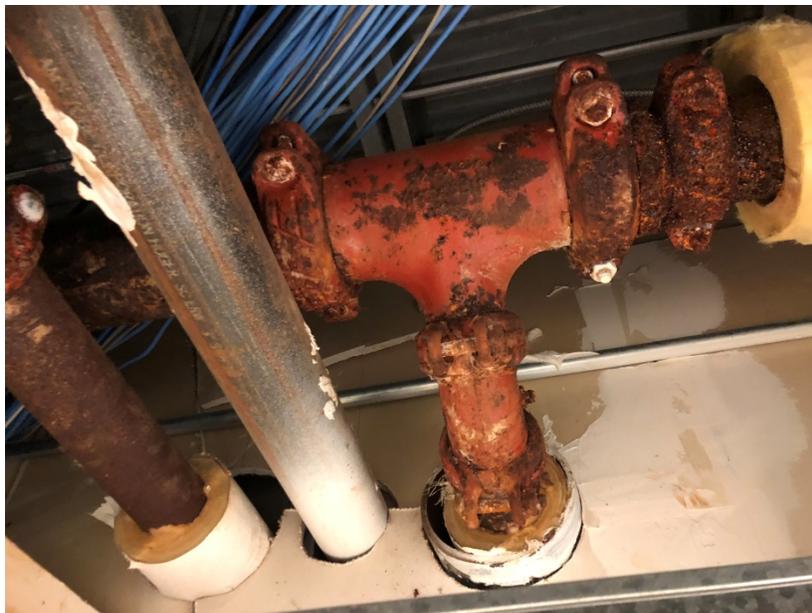
- The chilled water piping routed throughout the building is generally concealed above ceilings and insulated. However, there were many fittings and valves observed to be missing insulation. Much of the insulation currently installed is loosely-fitting and compromised by a non-continuous vapor barrier. The insulation that is currently installed seemed to fall short of current code minimum requirements for thickness and density. 1/2” thick and 1” thick insulation was observed where current code requires a minimum thickness of 1-1/2” (for dual-temperature use). Portions of missing and/or damaged insulation were observed above the ceilings throughout the building, thereby compromising the vapor barrier that is provided for much of the installed insulation. Condensation builds up on chilled water piping concealed in the humid ceiling cavity, causing “leaks” and damage to building interior finishes, as well as accelerated corrosion of valves and

pipe fittings. This condition also promotes the growth of mold which is a health concern for the educational facility.

Un-insulated & corroded HVAC Piping Above Corridor Ceiling

- Re-insulate entire dual-temperature HHW/ CHW piping system including all valves and fittings with 2” thick fiberglass insulation including a continuous vapor barrier, as is required by the current mechanical code for the heating hot water temperatures carried through these pipes. Any cooling-only branch piping may be provided with 1-1/2” thick insulation with a continuous vapor barrier.
