# **INDOOR AIR QUALITY ASSESSMENT**

**Shutesbury Elementary School  
23 West Pelham Road  
Shutesbury, Massachusetts**

Prepared by:  
Massachusetts Department of Public Health  
Bureau of Environmental Health  
Indoor Air Quality Program  
October 2022

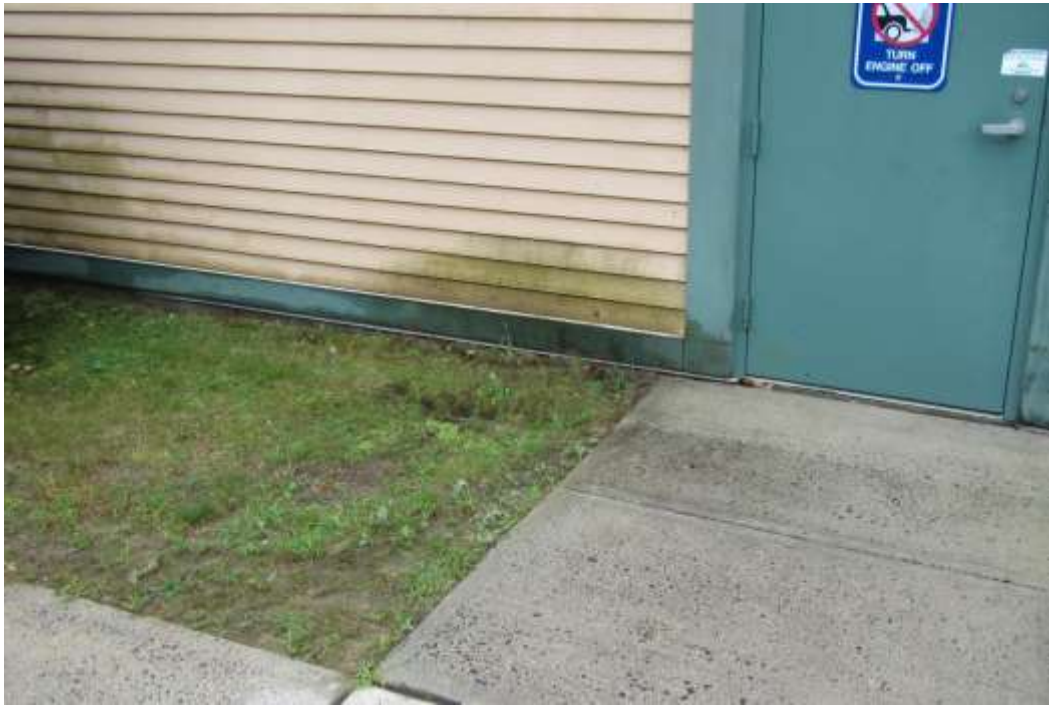
**Picture 1**

- The exterior walls are covered in places with moss (Picture 1), which can indicate chronic water exposure from rainwater. Moss tends to form on wood that retains moisture due to lack of drainage, poor design, and shade. Many of the wall surfaces of the SES do not see extended exposure to sunlight due to the topography and trees along the east side of the building.

**Moss on exterior walls**

- b. Repair or replace the exterior wall cladding.
  - c. Improve drainage through installation of a drain system or further regrading of ground around the SES as detailed in short-term recommendation #5.
  - d. Repair or replace the exterior fenestration system.
2. Conduct a building-wide ventilation system assessment. Based on historical issues with air exchange/indoor air quality complaints, age, physical deterioration, and availability of parts for ventilation components, such an evaluation is necessary to determine the operability and feasibility of replacing the equipment.
  3. Consider installing a gutter/downspout system along all roof edges. Once completed, conduct repairs to roof eave wood.

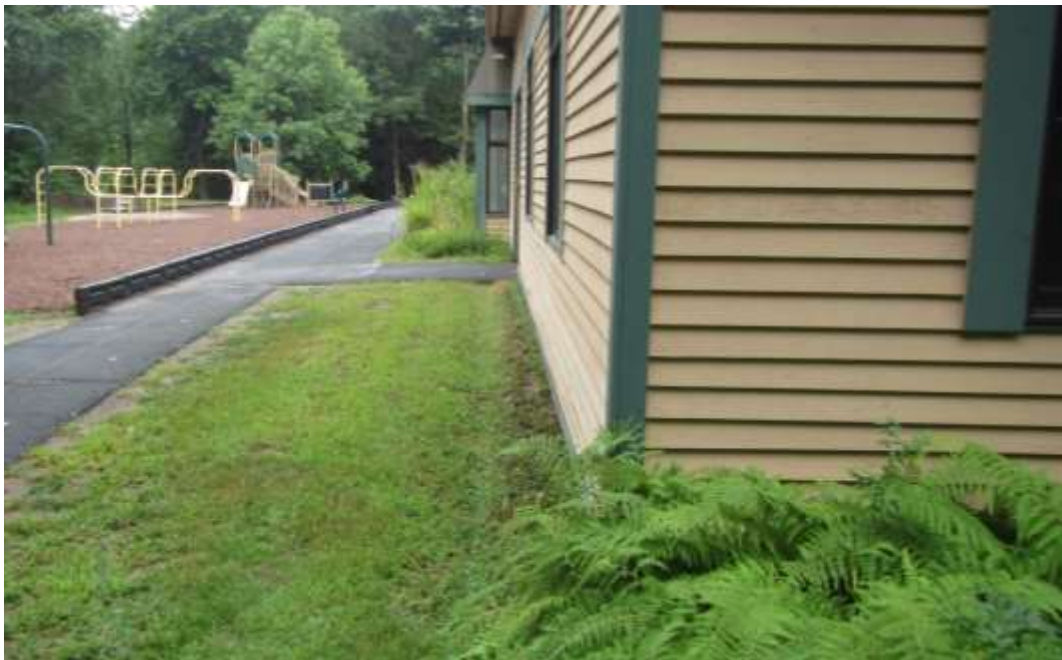
**Picture 2**

- With exception of the exterior wall around doors, the roof does not have a gutter/downspout system to capture rainwater. Rainwater flows off the roof edge to impact on the base of the exterior wall soil (Picture 2), as shown by extensive furrows. As rainwater impacts the ground with force, soil becomes compressed, which creates furrows. This allows for water to puddle at the base of the exterior walls, which in turn, likely splashes exterior walls. The repeated wetting, and lack of drying, of exterior walls likely provides the condition that results in moss growth on sills, which then can accelerate the weathering/damage to the wood.

**Furrows in lawn/soil from rainwater impact**

3. Examine the feasibility of preventing rainwater pooling along the exterior walls by regrading soil. In general, a water-resistant material in a configuration of 1' in height and 5' in length is recommended to increase drainage of rainwater.

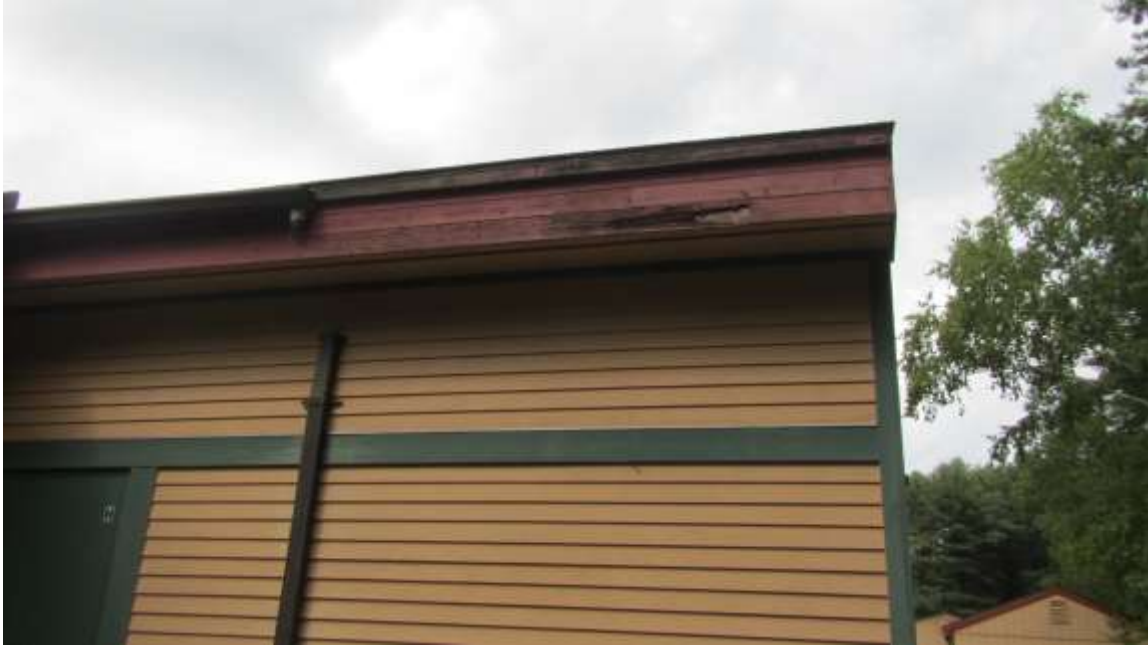
**Picture 3**

- Without gutters equipped with proper flashing to transition rainwater from roof to a gutter, roof eaves have been routinely exposed to rainwater, which has caused significant damage (Picture 3).

**Water-damaged roof eaves**

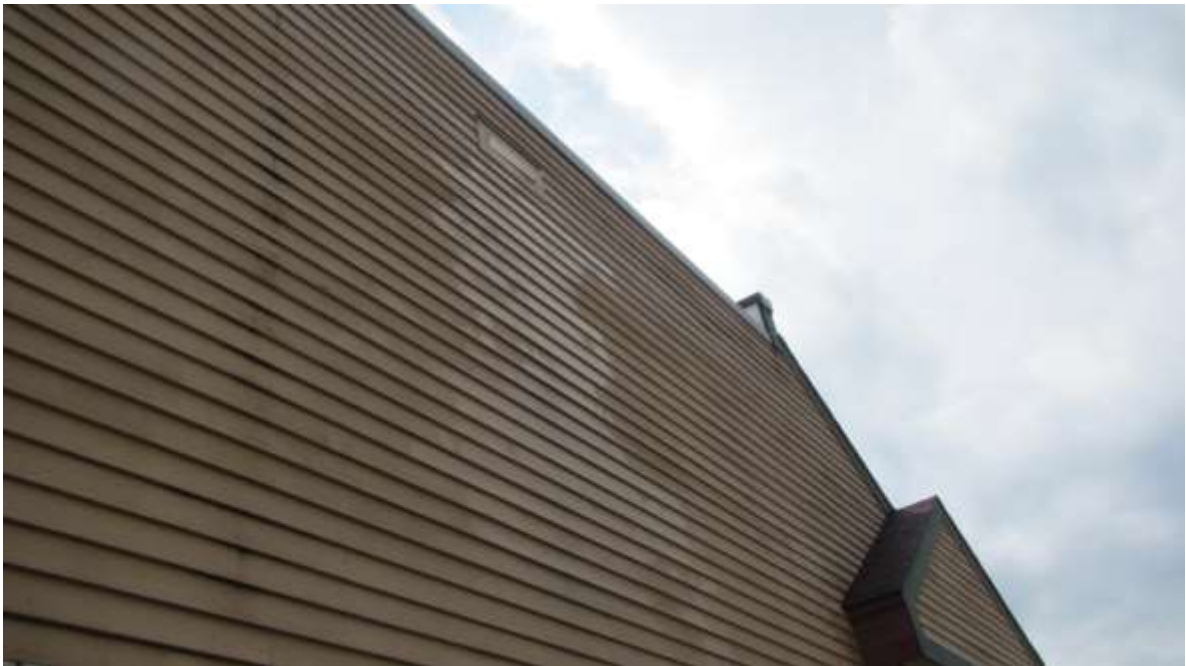
**Picture 4**

- In one instance, water was found leaking from a gutter, which can indicate accumulated debris in the gutter and/or gaps in seams.
- Around the original gymnasium roof, scuppers were found without exterior downspout drainage which wets exterior walls (Picture 4).

**Wall wet from rain draining from scupper**

6. Consider removing all plants in the interior courtyard to reduce water accumulation.
7. Consider installing a downspout on all scuppers to reduce exterior wall damage.

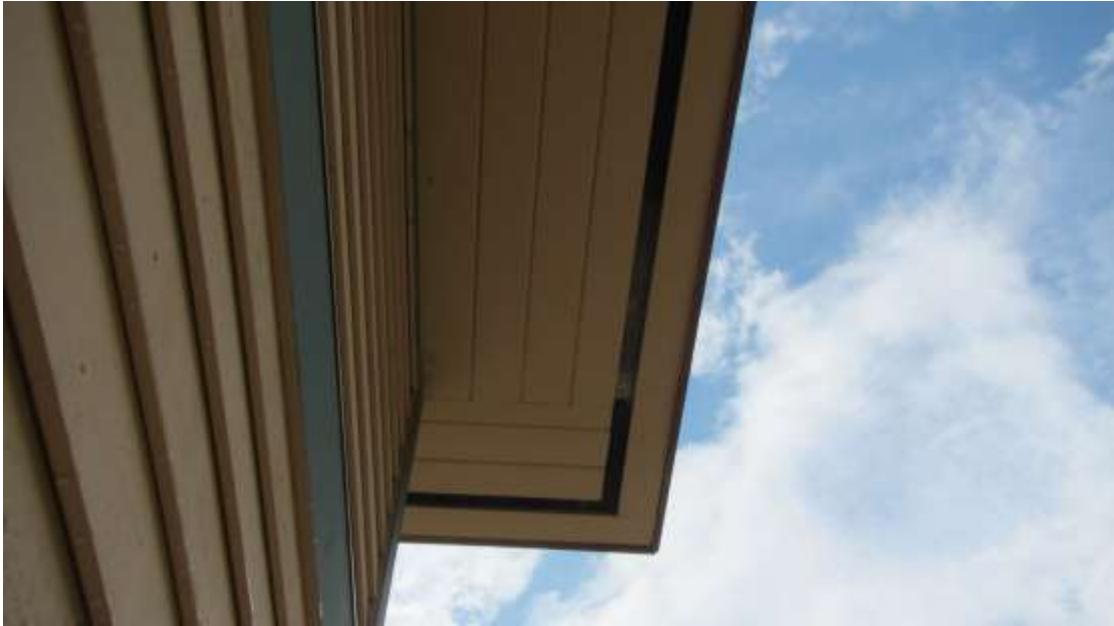
**Picture 5**

- Shutesbury Town and School officials, reported that the SES experienced significant ice dams in recent winters. To prevent ice dams, roofs are equipped with both soffit vents (Picture 5) and ridge vents. Roof vents prevent ice dams by reducing the temperature of

the roof surface so accumulated snow doesn't melt and refreeze. IAQ staff could not determine if ridge vents are open to outdoors. If ridge vents are open, an individual can see outdoor light at the peak of the roof. If the ridge vent is not open, waste heat from the building may accumulate in the roof to cause melting and refreezing, leading to ice dams.

**Soffit vents**

1. Examine whether roof ridge vents are open. Consider opening vents if closed.
2. Repair leaking gutters. Ensure that all roof drains, gutters, and downspouts are regularly cleaned of debris.

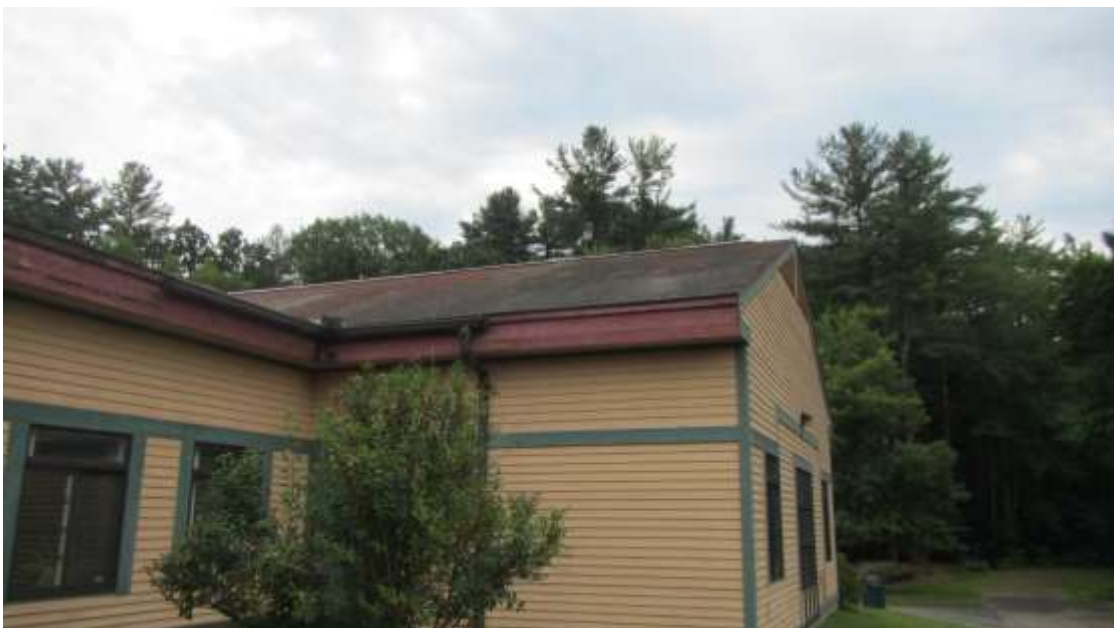
**Picture 6**

- Significant portions of the SES roof are in continuous shade due to a stand of high trees east of the building. Due to this shading, the roof is discolored from moss/organic debris, which indicates chronic moistening (Picture 6). Without direct sunlight, roof materials can remain wet which can then damage shingles and the underlayment of the roof, which can result in water damage to the building interior.

**Discolored roof**
